# TENTH QUARTERLY PROGRESS REPORT FOR THE APPLICATIONS TECHNOLOGY SATELLITE GRAVITY GRADIENT STABILIZATION SYSTEM

1 November 1966 Through 31 January 1967

CONTRACT NO. NAS 5-9042

NATIONAL AERONAUTICS AND SPACE ADMINISTRATION
A.H. SABELHAUS
ATS TECHNICAL OFFICER

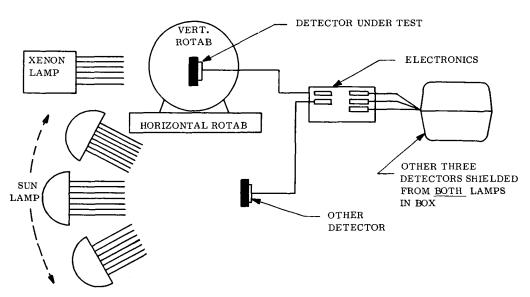
Figure 5-1. SAS Detector Identification Test Setup

At the start of this reporting period, the Flight 2 SAS was undergoing acceptance tests at GE. Apparent anomalies in the operation of the detectors were traced to "walking" of the arc in the solar simulator xenon lamp. The lamp was replaced, and the acceptance tests proceeded without incident; testing was completed during the last week of November. For the first time, the acceptance tests included checks of system operation with pairs of detectors illuminated. The purpose of this test is to assure that there has been no electronic failure which would cause improper switching of detector identification and sun angle output signals. This type anomaly occurred on the Gravity Gradient Test Satellite (GGTS), and was investigated as described on Page 5-5 of the Ninth Quarterly Progress Report. The equipment set-up for this test is shown in Figure 5-1. The test requires that, as long as the system identifies the detector on the rotary table as "most illuminated", there be no change in the angular readout at nominal sun angles of 30 and 60 degrees. The type anomaly seen on GGTS is detectable by this method. While a given detector is on the rotary table, each of the other four detectors is illuminated in turn at an intensity below one solar constant, and the required performance verified.

The process is repeated as each of the five detectors undergoes complete functional test on the rotary table, thus assuring that all possible combinations of two illuminated detectors are checked.
